Decommissioning of Westwold Flowing Artesian Well

by David Thomson, M.Sc., P.Geo

BCGWA Regional Meeting, Vernon, BC

October 18, 2019

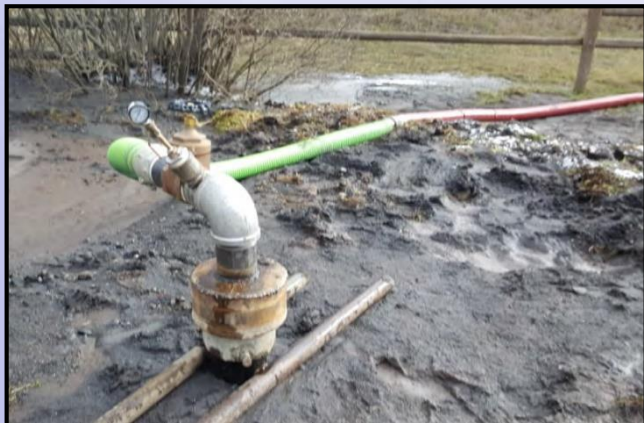
- March 10-11, 2016
 - WTN 112429 drilled to 280 feet below ground
 - Initially reported flowing artesian at 60 US GPM
 - Subsequently estimated up to 750 US GPM
 - Four inch reducer welded onto six inch casing

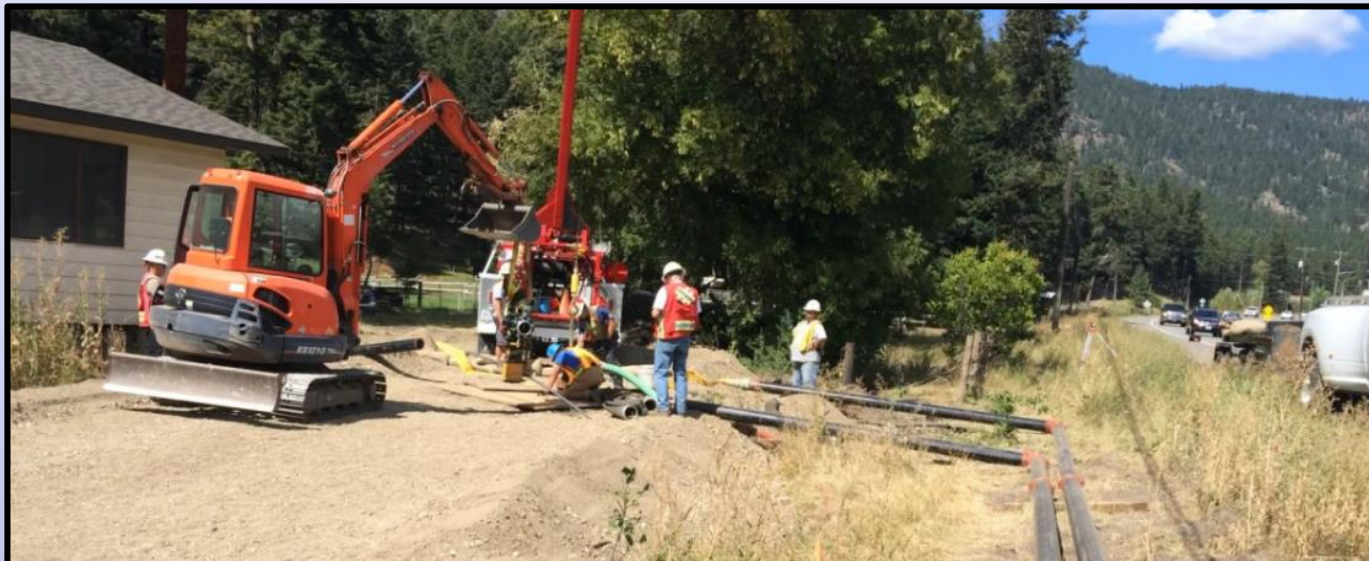
- Well owner and Well Driller initially operating under voluntary compliance
- June and July: Non-compliance warning and advisory letters sent to Well Driller and Well owner during summer

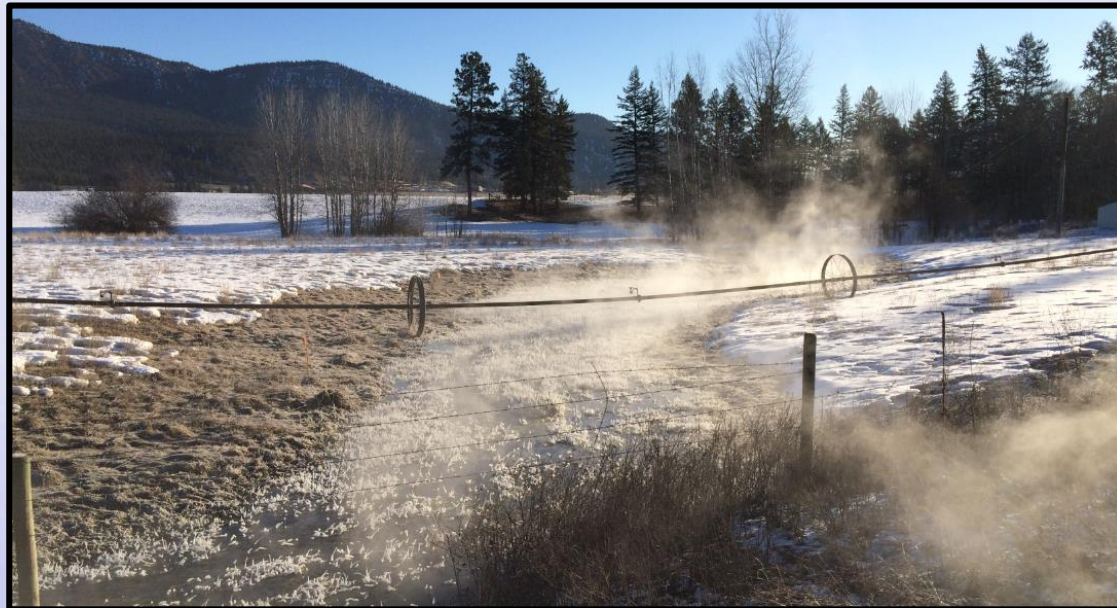
- FLNRORD commissioned review of initial options analysis
- Regular monitoring and reporting by Driller ceased due to disputes about financially responsible party

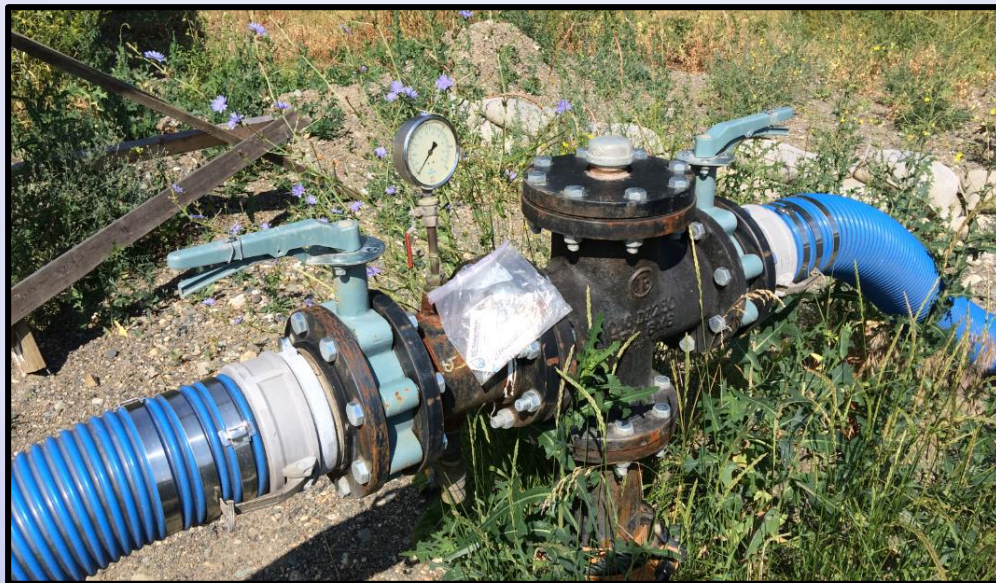
- Field receiving discharge still unable to be farmed
- Ministry of Transportation ongoing concerns
- Prepared funding submission to executive
- Request for proposal for well closure posted and awarded

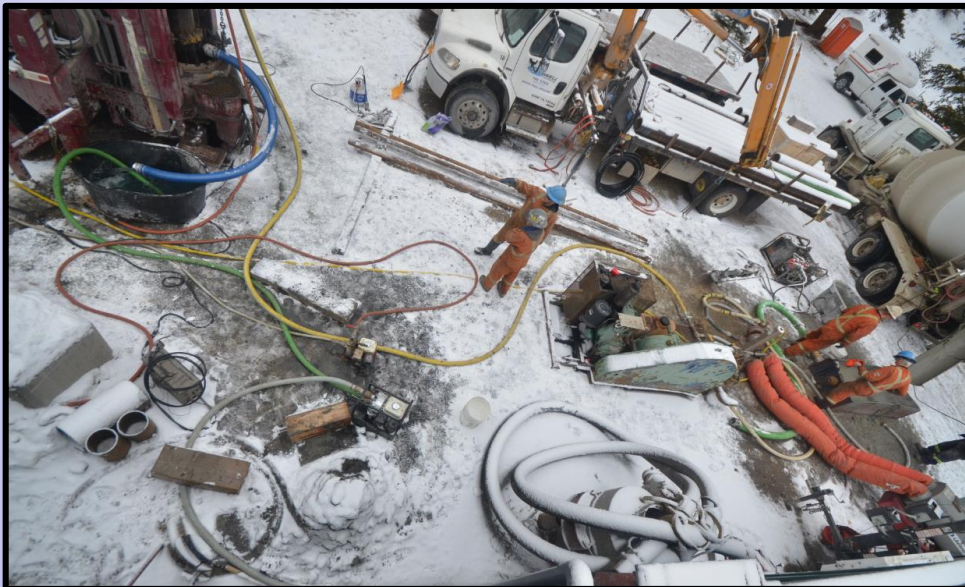
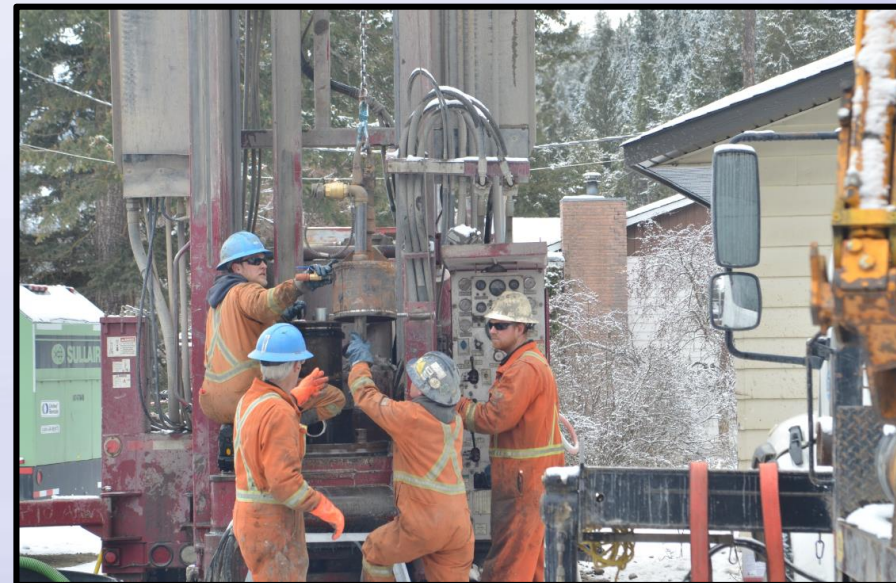
January – desktop planning, permits/approvals

February – site preparation

March – drill relief well, test, decommission flowing well
